STRUCTURAL INTEGRITY RESERVE STUDY

HARBOR OAKS PLACE CONDOMINIUM

30 TURNER STREET
CLEARWATER, FLORIDA 33756

DECEMBER 2024

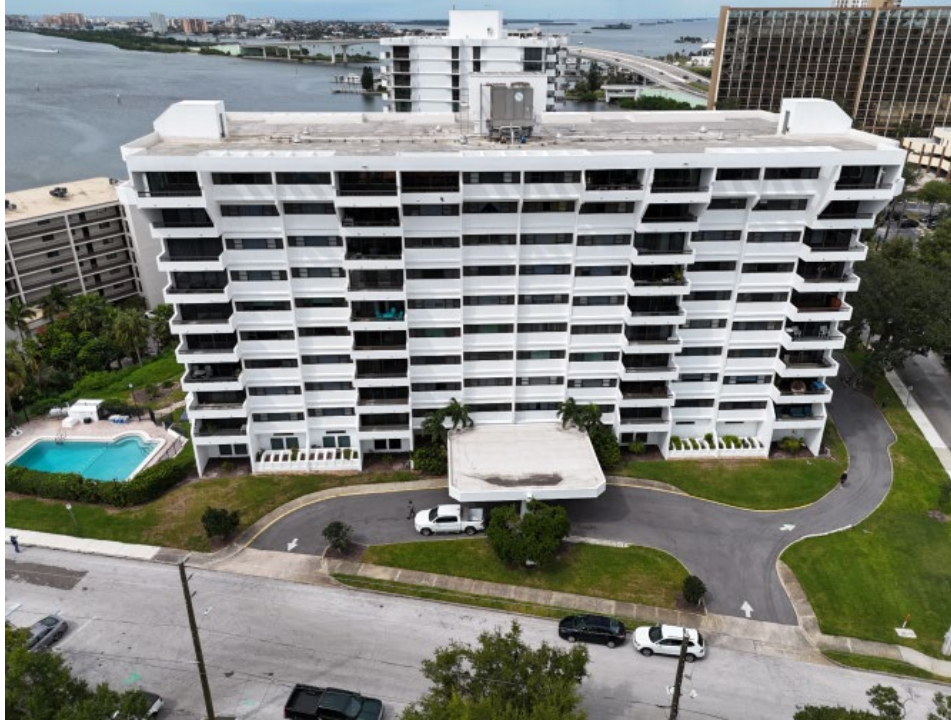
1. View of the front elevation of the subject building.

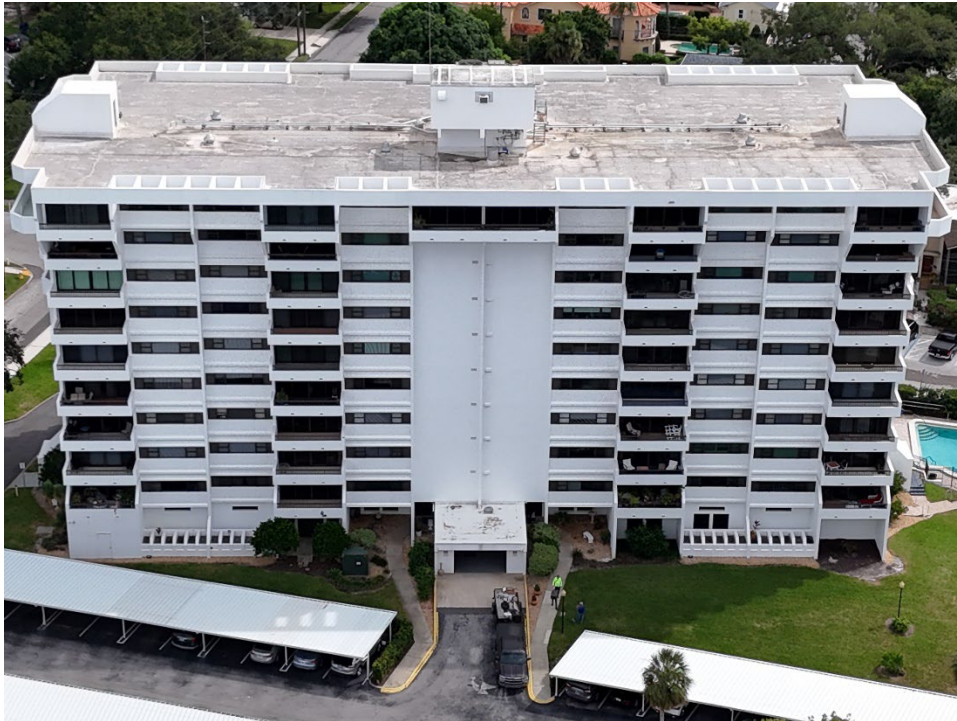
2. View of the rear elevation of the subject building.

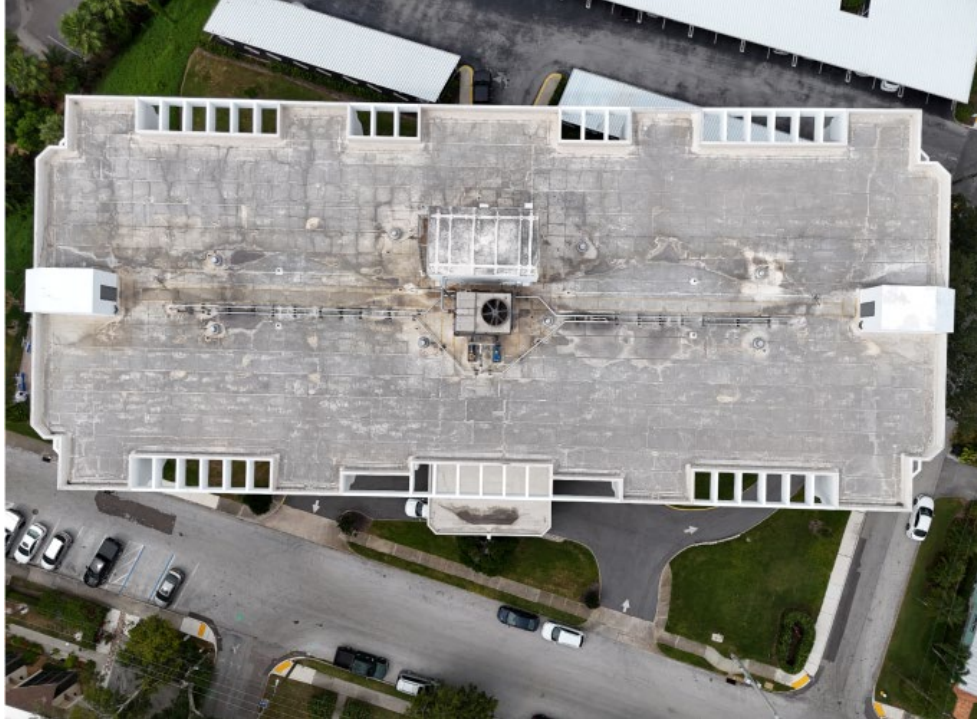
3. Overview of the roof.

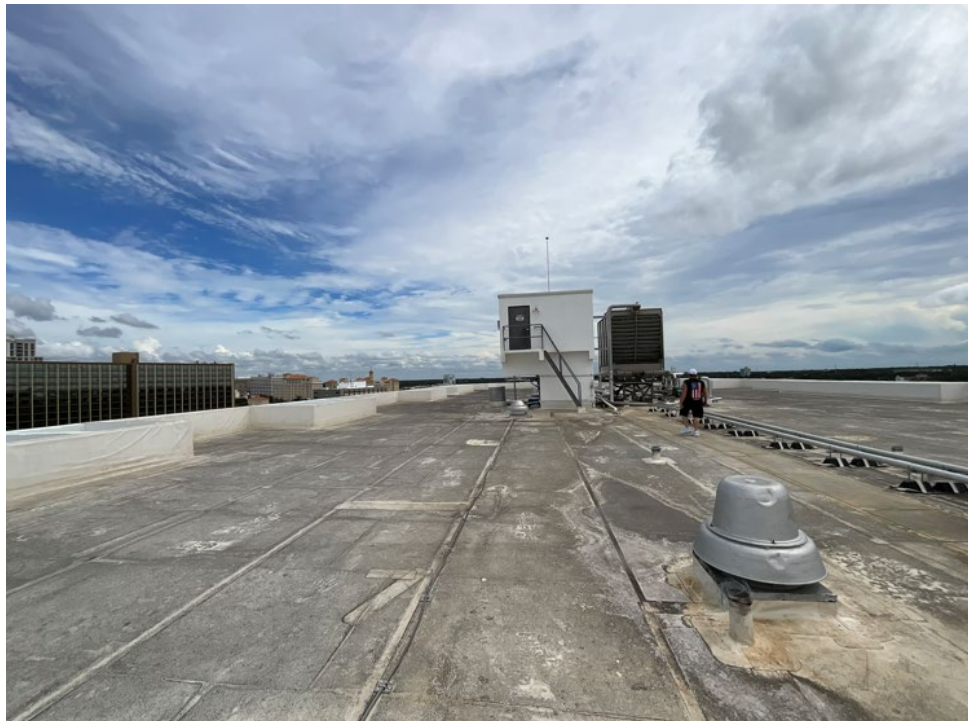
4. View of the roof of the subject building.

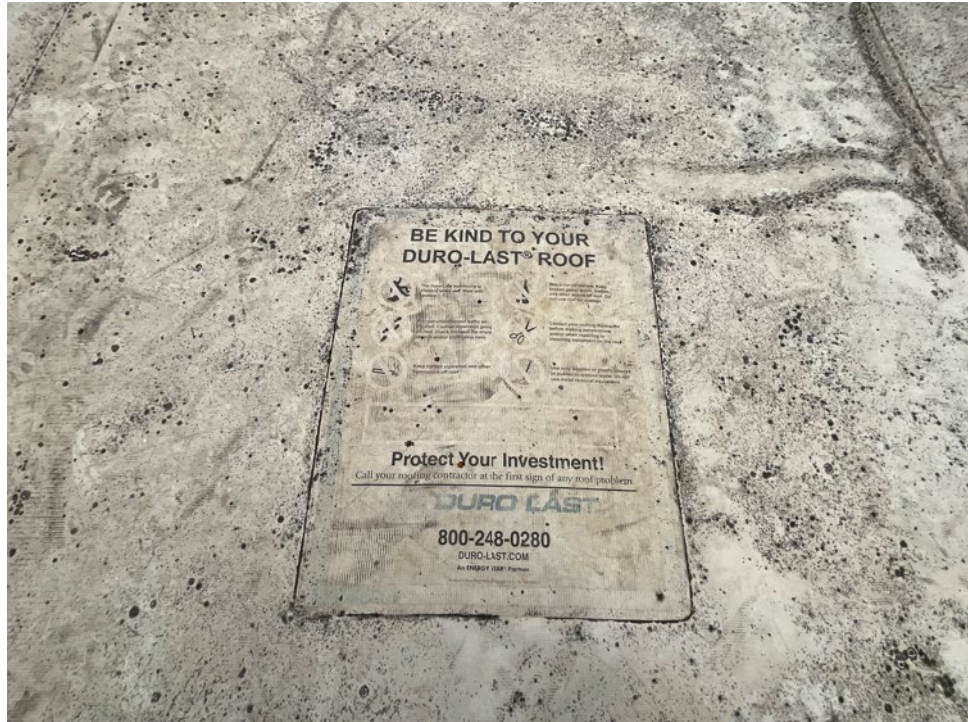
5. View of the roof material placard.

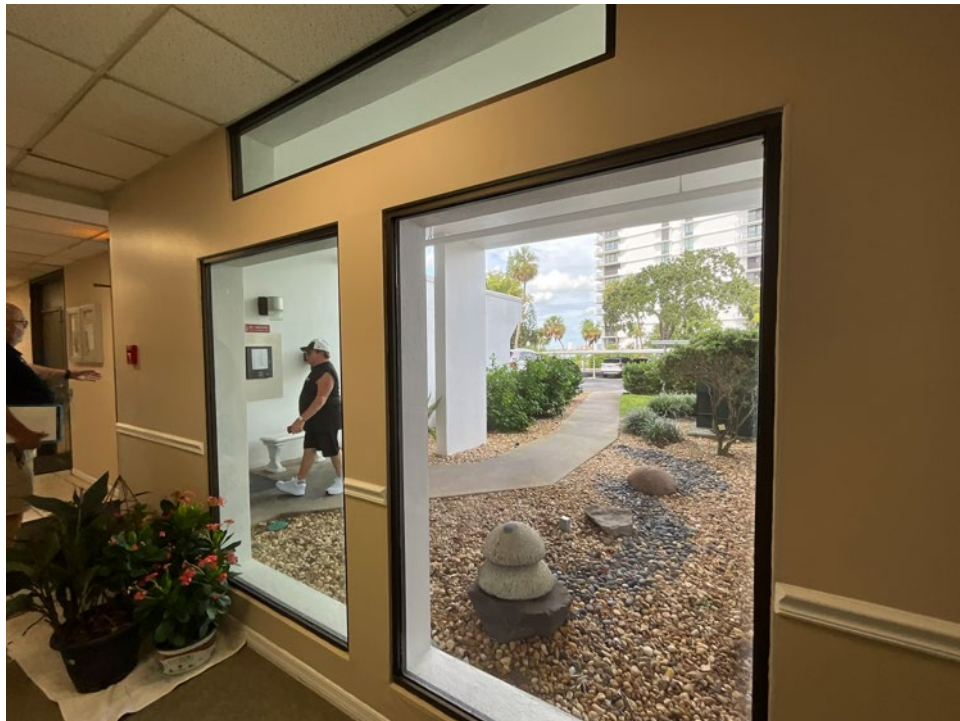
6. View of the typical ground-level common area windows.

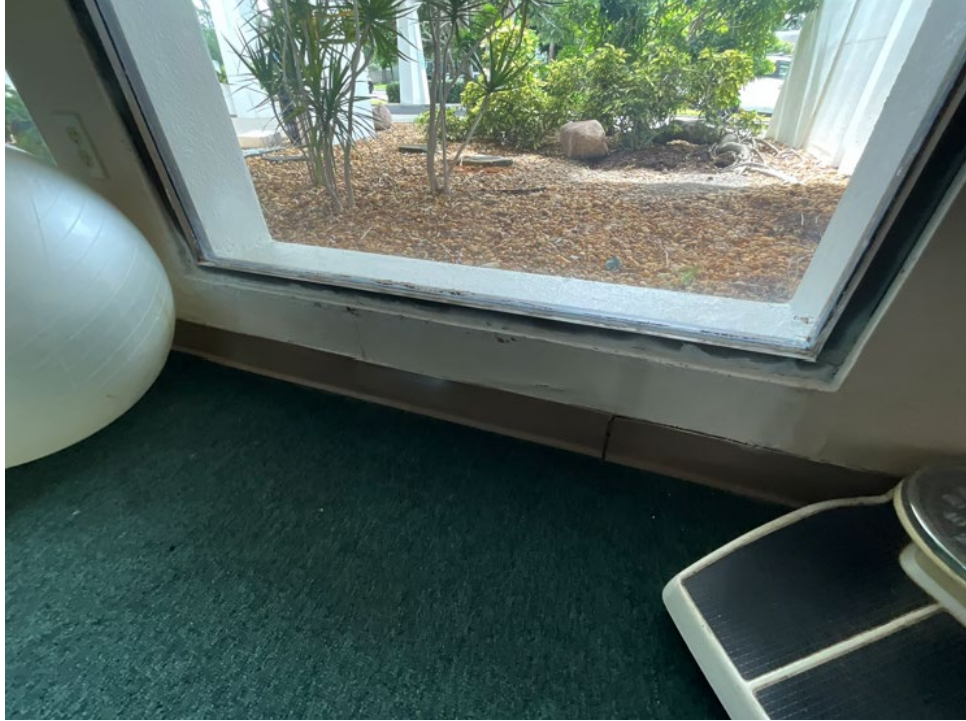
7. View of typical moisture intrusion at the common area windows.

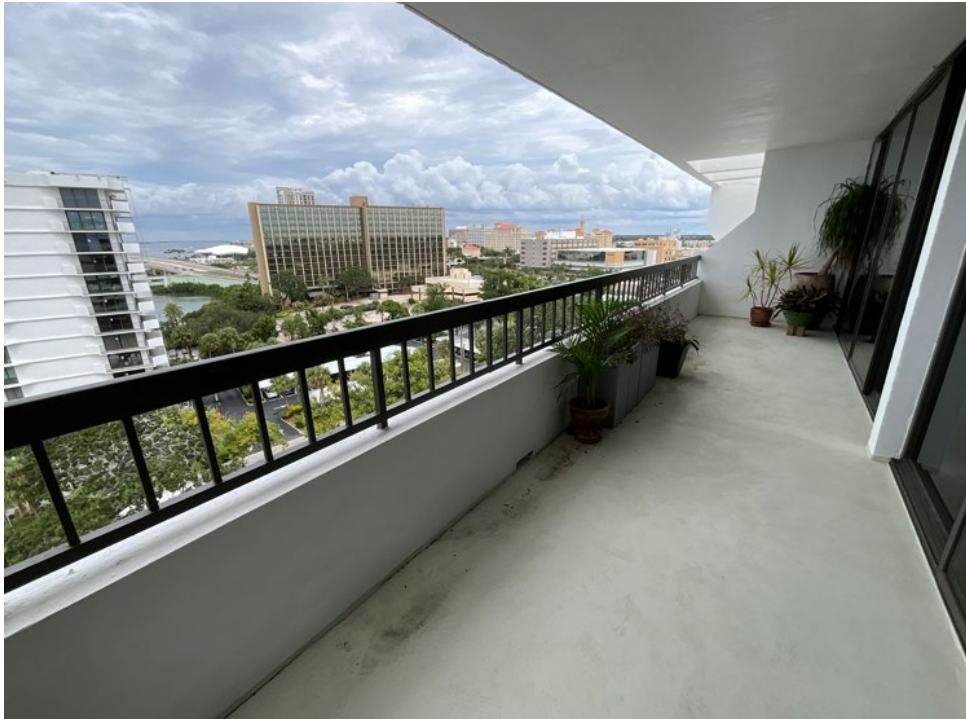
8. View of a penthouse balcony.

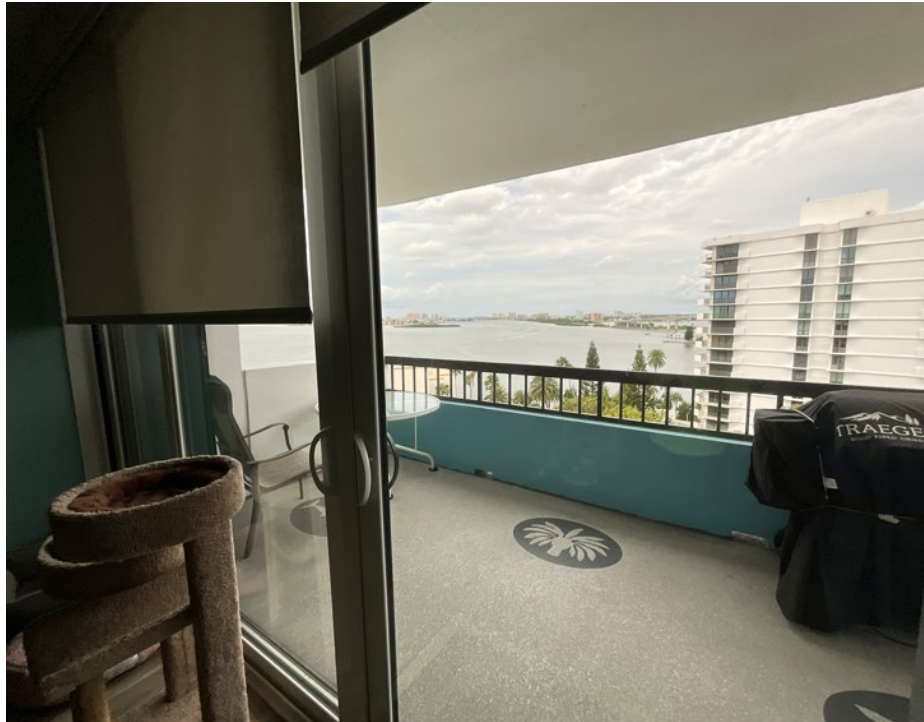
9. View of a typical unit balcony.

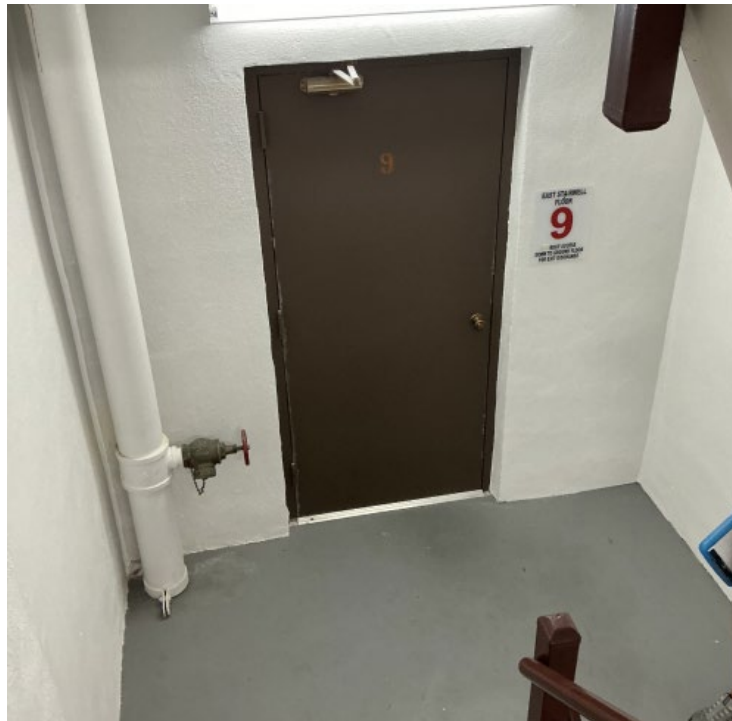
10. View of a typical stairwell floor entry and fire suppression system standpipe.

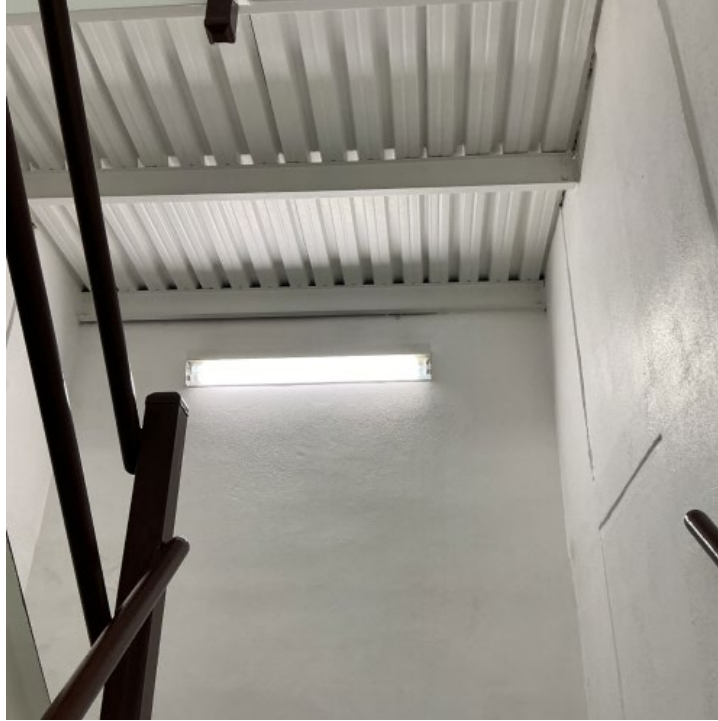
11. View of the stairwell concrete landing metal deck pan.

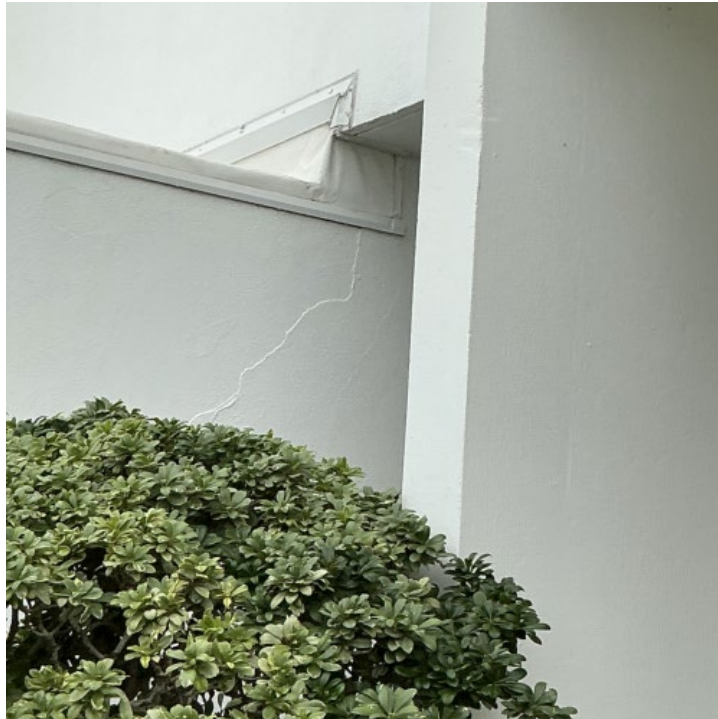
12. View of a stair-step crack in the ground-level CMU wall at the rear entrance.

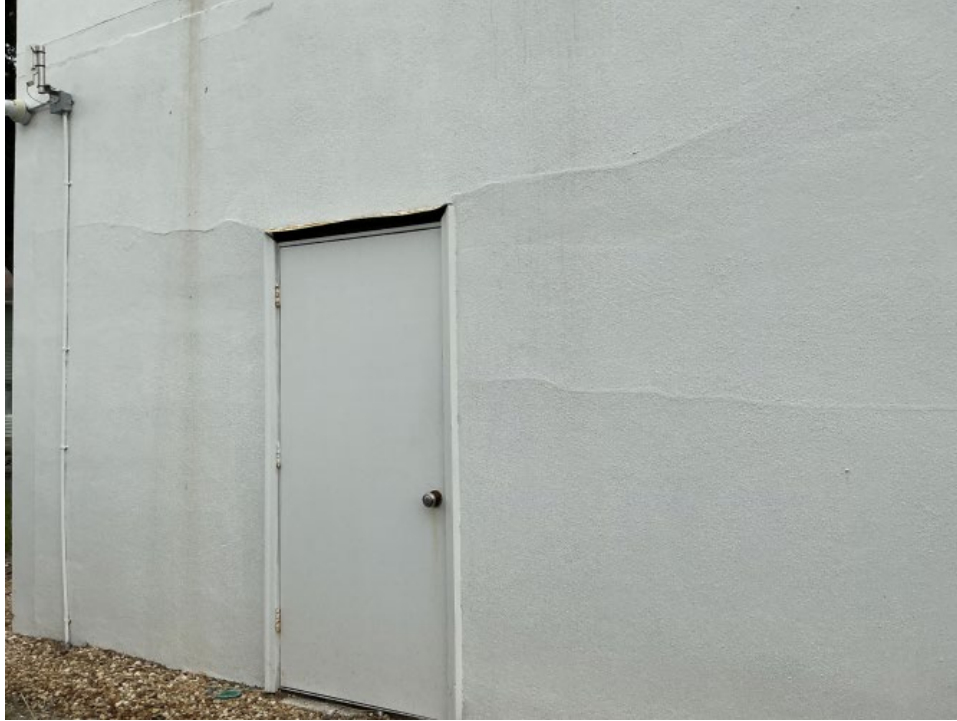
13. View of stucco cracks in the rear ancillary room wall.

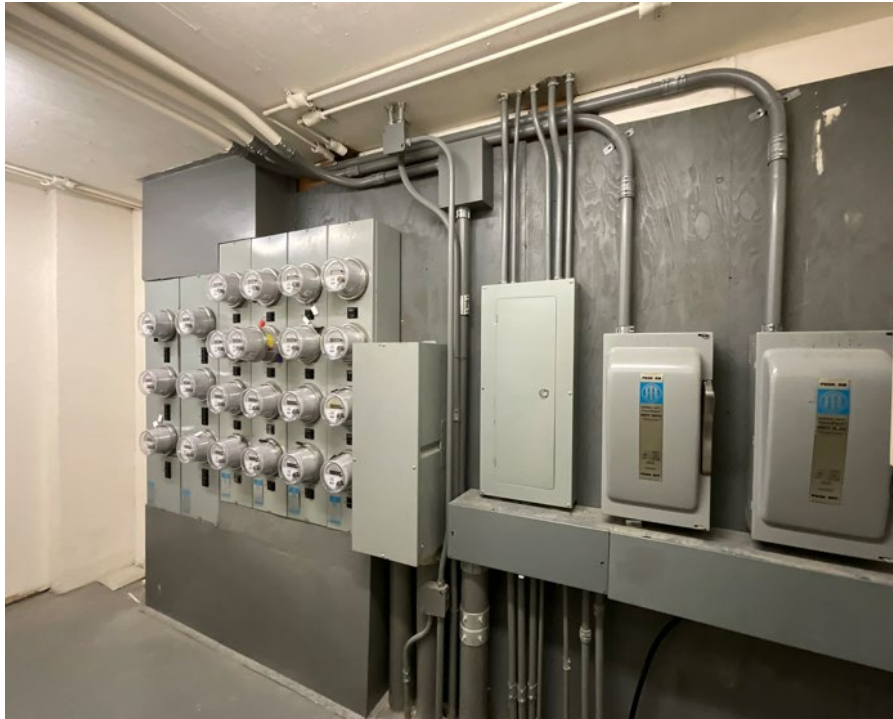
14. View of the typical meter stack, breaker panel, and sub-switches in the electrical rooms on floors 3, 6, and 9.

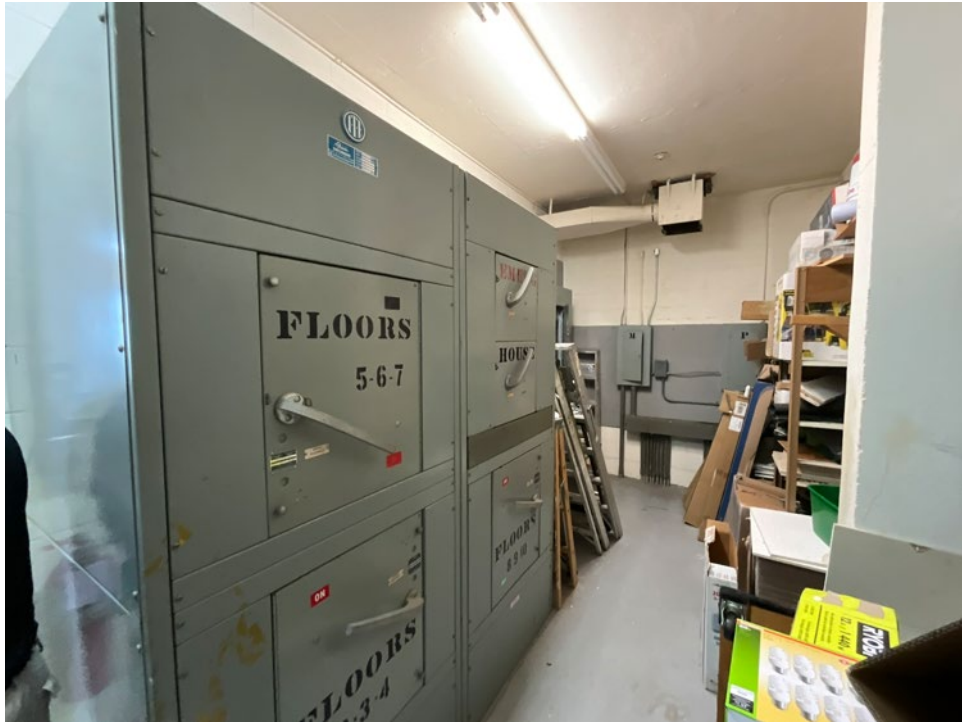
15. View of the main electrical switches.

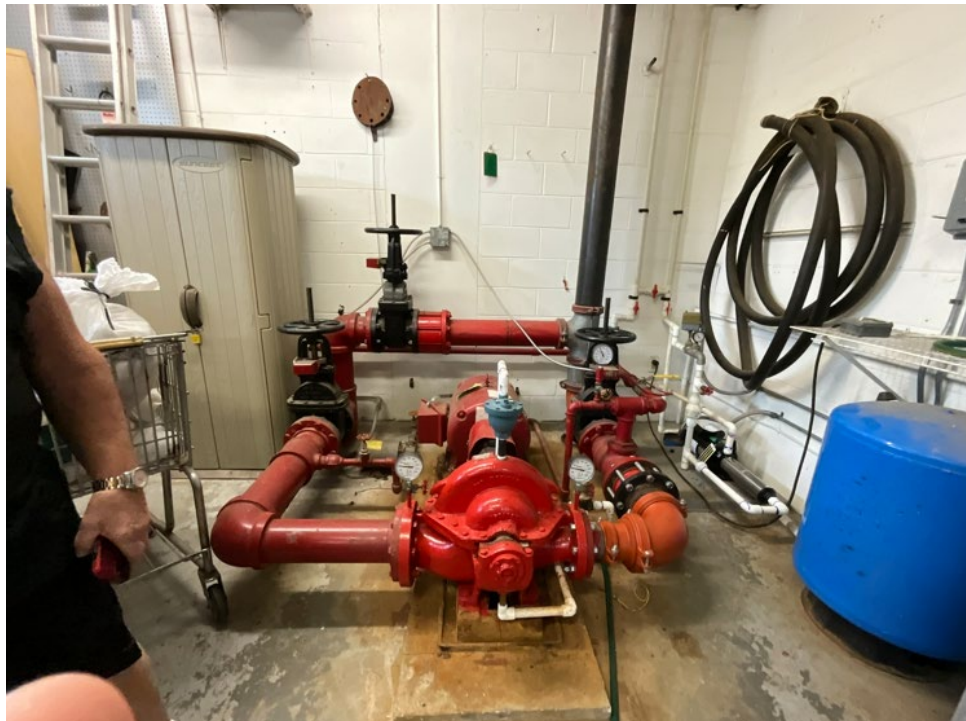
16. View of the fire suppression system pump.

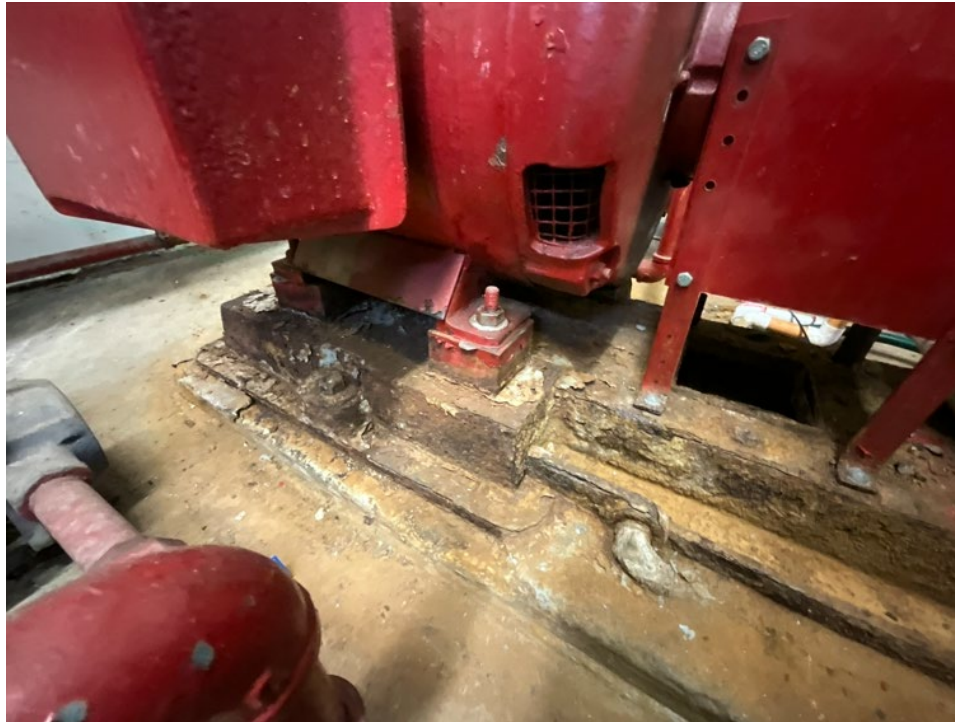
17. View of corrosion at the fire suppression system pump mounts.

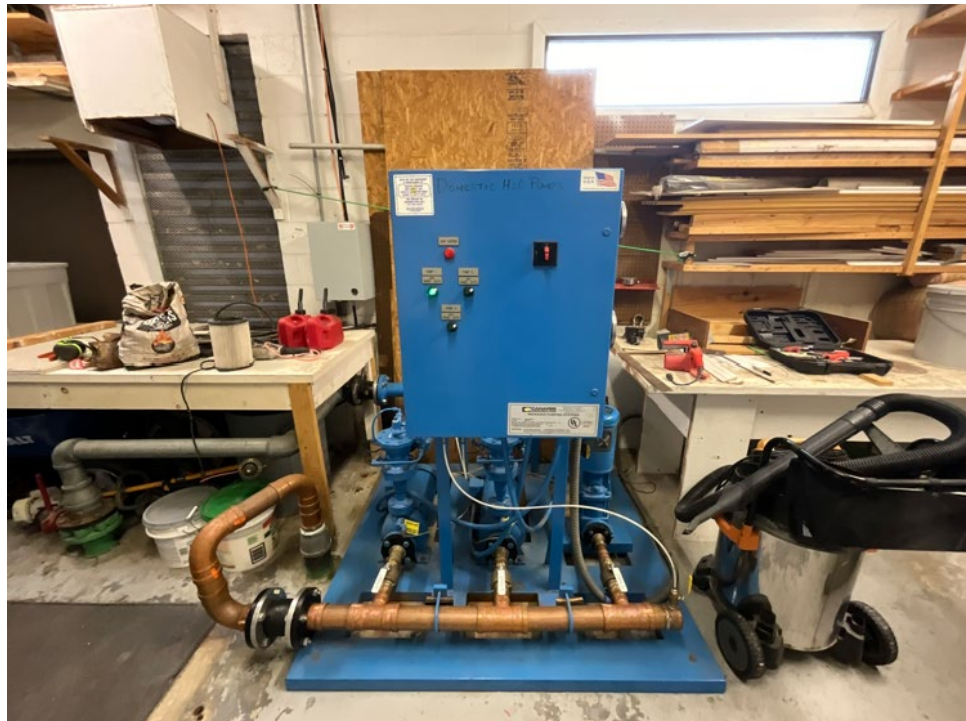
18. View of the domestic water pump system.

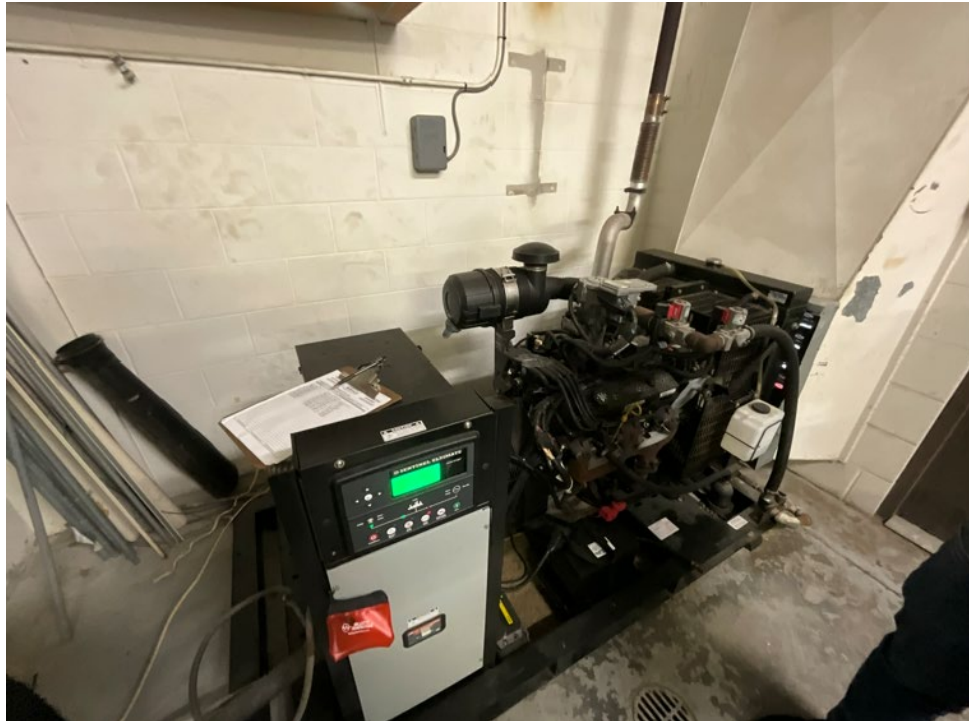
19. View of the backup generator.
