PHASE 1 MILESTONE INSPECTION REPORT

Harbor Oaks Place Condominium

30 Turner St.
Clearwater, Florida 33756

Regarding: Phase 1 Milestone Inspection

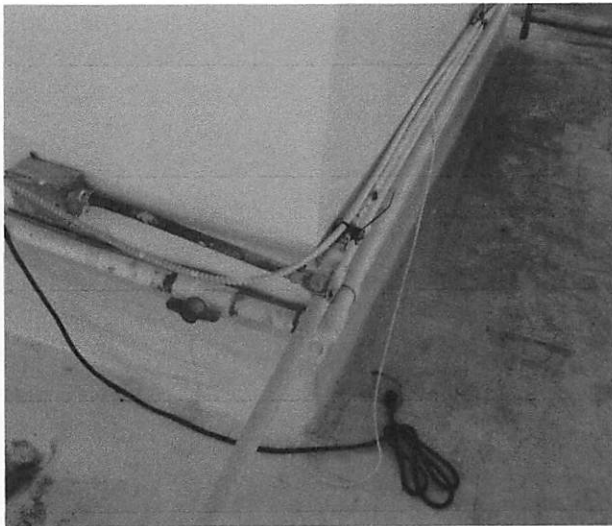
3.2 Corroded electrical conduit on the exterior of the elevator tower on the roof (See Photo 2)

PHOTO 2:
Observed rusted electrical conduit
along the elevator penthouse.

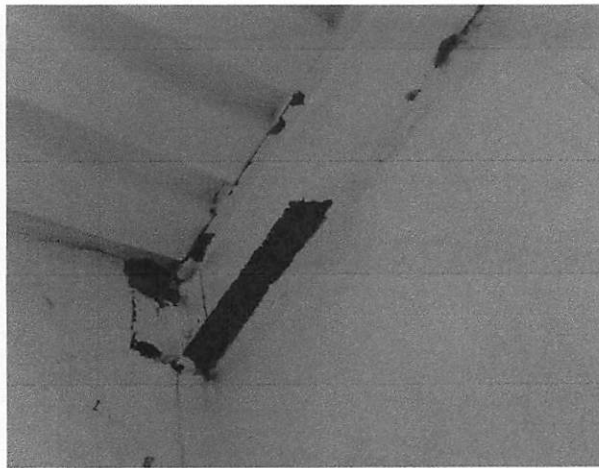
PHOTO 3:

3.4 Rusted stairwell I-Beam support in the East stairwell between floors 5 and 6
(See Photo 3)

Observed rusted stairwell I-Beam support

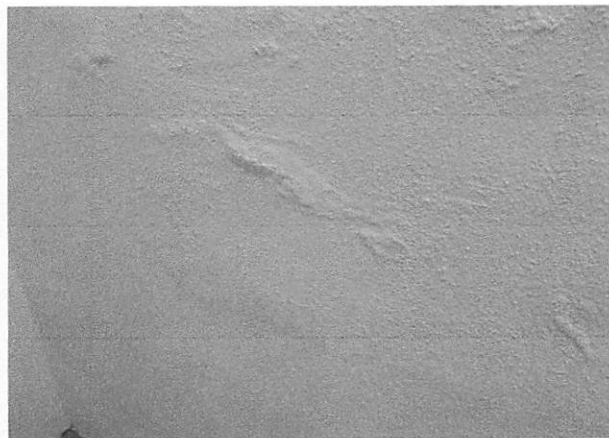
PHOTO 4:

3.3 Efflorescence observed at various areas within the East stairwell (See Photos 4 and 5)

Efflorescence observed on the exterior wall within the East stairwell on the 10th floor

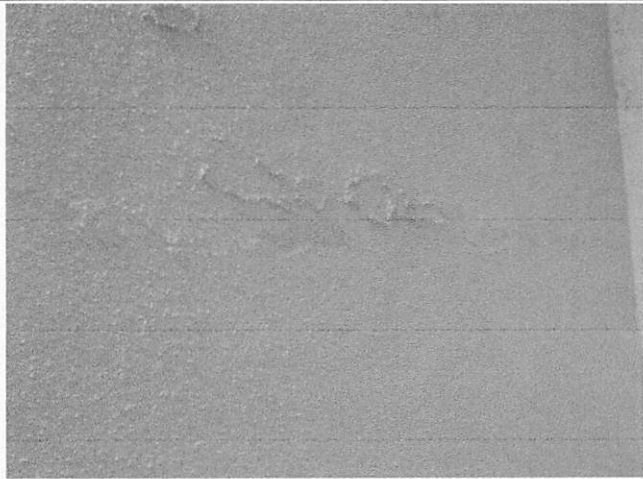
PHOTO 5:

Efflorescence observed on the exterior wall within the East stairwell on the 7th and 8th floor

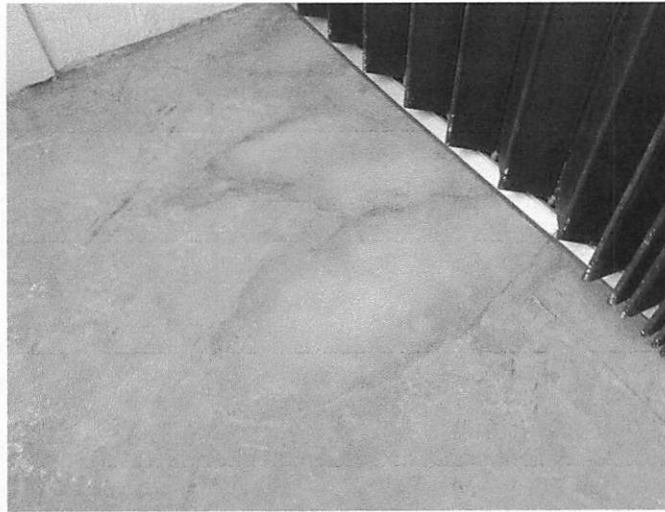
PHOTO 6:

3.1 Cracks, spalls, and other indications of concrete deterioration were observed to have been repaired at isolated locations on the balcony slabs. (See Photo 6.)

Balcony floor repairs were completed due to a spalling issue. (Unit 807)
