Windstorm Mitigation Report (OIR-B1-1802)

Harbor Oaks Place, Inc.

30 Turner St, Units 201-908, 1001-1006

As of 07-12-2024 | FPAT File# MUD2422846

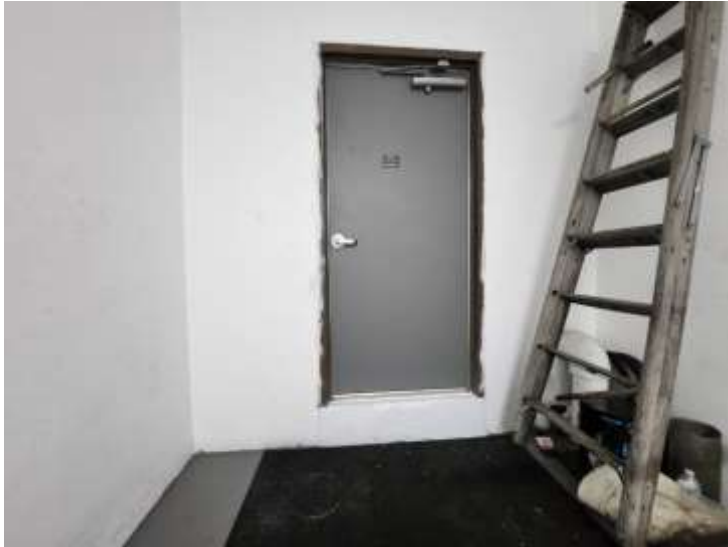
Roof Construction

- 3. Roof Deck Attachment:** **Reinforced Concrete Roof Deck**
Comments: Inspection verified a roof structure composed of cast-in-place or pre-cast structural concrete designed to be self supporting and integrally attached to the wall / support system.

- 4. Roof to Wall Attachment:** **Structural**
Comments: Inspection verified a roof structure composed of cast-in-place or pre-cast structural concrete designed to be self supporting and integrally attached to the wall / support system.

- 5. Roof Geometry:** **Flat Roof**
Comments: Inspection verified a flat roof shape.
- 6. SWR:** **No**
Comments: SWR does not apply to reinforced concrete roof decks.
